Changes to the Building Code for Emergency Lighting

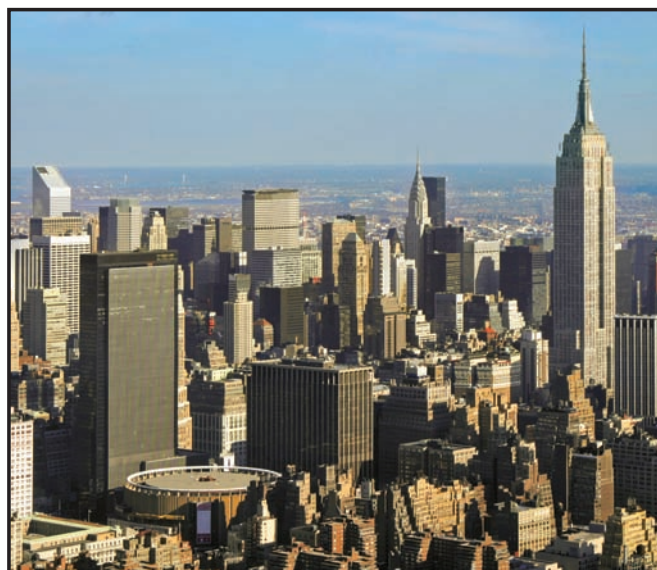
All New York buildings over 7 stories high now must have photoluminescent markings in their stairwells

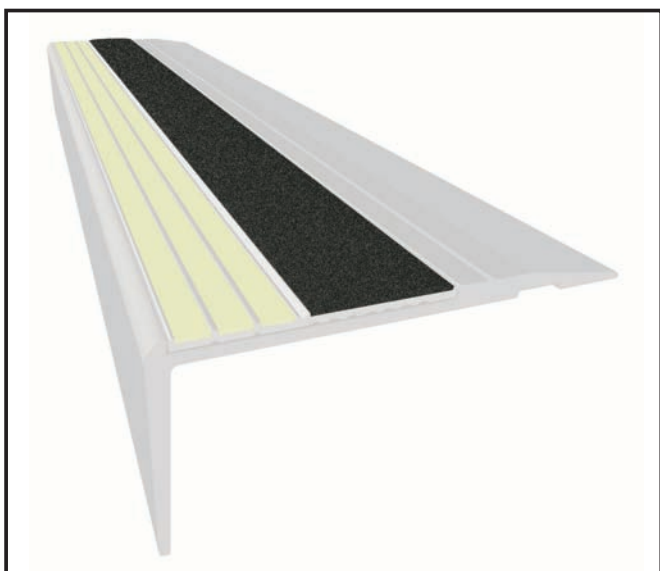
Ecoglo step nosings incorporate a hard wearing anti-slip mat as well as a photoluminescent component to prevent slips and falls 24 hours a day.

developed a unique automated process which applies and then bakes in anti-slip and photoluminescent powders. The 180° heat applied integrally bonds the powder to the aluminium meaning thousands of people can walk on Ecoglo products thousands of times with no wear and tear.

Some steps are just too hard to see, whether it be day or night. With Ecoglo you can clearly see the step whatever the light conditions as the combination of photoluminescence and the non-slip mat creates superior step edge contrast.
